Experimental evaluation of shear and compression strength of masonry wall before and after reinforcement: deep repointing

M. Corradi^{*1}, C. Tedeschi², L. Binda³ and A. Borri⁴

Keywords: masonry, shear strength, reinforcement, deep repointing

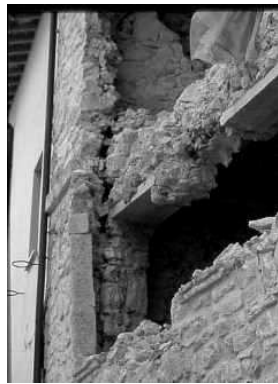
Figure 1 Double leaf wall

Multiple leaf stone masonry structures are widely encountered in Italian and European historic centres. Dwellings but also other important buildings of these centres are characterised by a typical construction technique which is the double leaf wall with transversal connections (diatons). Particularly in the case of dwellings, this connection is frequently missing or very rare due to poor workmanship or lack of large stones crossing the wall section (Fig. 1). So the section of the wall consists of two external leaves with a gap between them filled with mortar, inconsistent material and small pieces of stones. It is now well known by direct experience that under vertical and/or horizontal actions the two leaves tend to separate (Fig. 2) and a partial or total collapse of the wall can take place (out-of-plane mechanisms). This mechanism of collapse has frequently occurred during seismic events in Italy and elsewhere. One of the most difficult tasks for engineers and architects is the repair and/or retrofit of this damage.

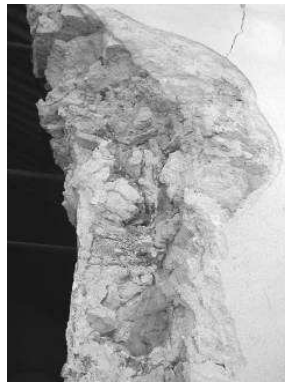
Figure 2 Effect of eccentric loading due to RC tie beam positioning.

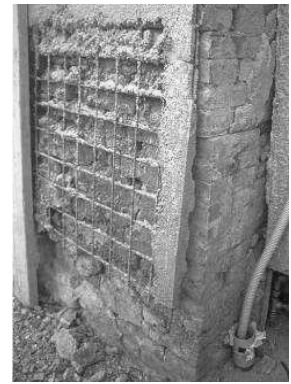
Figure 3 Only some spots were injected in the case of this wall with a very low percentage of voids.

The morphology of the walls suggested that in some cases repair by injection were not appropriate due to the fact that inside the masonry there was practically loose material and no voids were present [3]. Therefore before applying the technique, appropriate tests were carried out in laboratory on sampled materials and also on site [4].

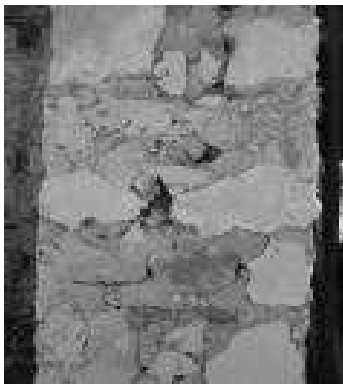
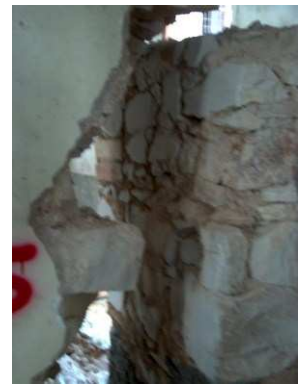
Figure 9 a) Ponte di Postignano bulding; b) Farnetta building; c) Trevi building.

The second building situated in Farnetta was completed at the beginning of the 20th cent. as a rural house. The plan is rectangular with the longest side of 15 m. The building is two floors high with the ground floor used as goods storage subdivided in three rooms (Fig. 9b); the walls are

This large building in Trevi was built at the end of the 19th cent. as a dock for agricultural purposes. The plan is square and the dock is three floors high (Fig. 9c). The masonry is made with two leaves of roughly cut stones with a thickness of 670 mm. The chosen panels had some courses made with bricks at regular spacing. In the internal part of the wall section the mortar filled all the voids between the stones, but no connection was found between the two leaves of masonry.
